**NATIONAL TRANSPORTATION SAFETY BOARD**

**Sound Spectrum Study Cockpit Voice Recorder**

DCA98RA013

Location : Palembang, Indonesia  
Date : December 19, 1997  
Time : About 1614 Local Time  
Aircraft : Silk Air Flight MI-185, a Boeing B-737-36N,  
9V-TRF

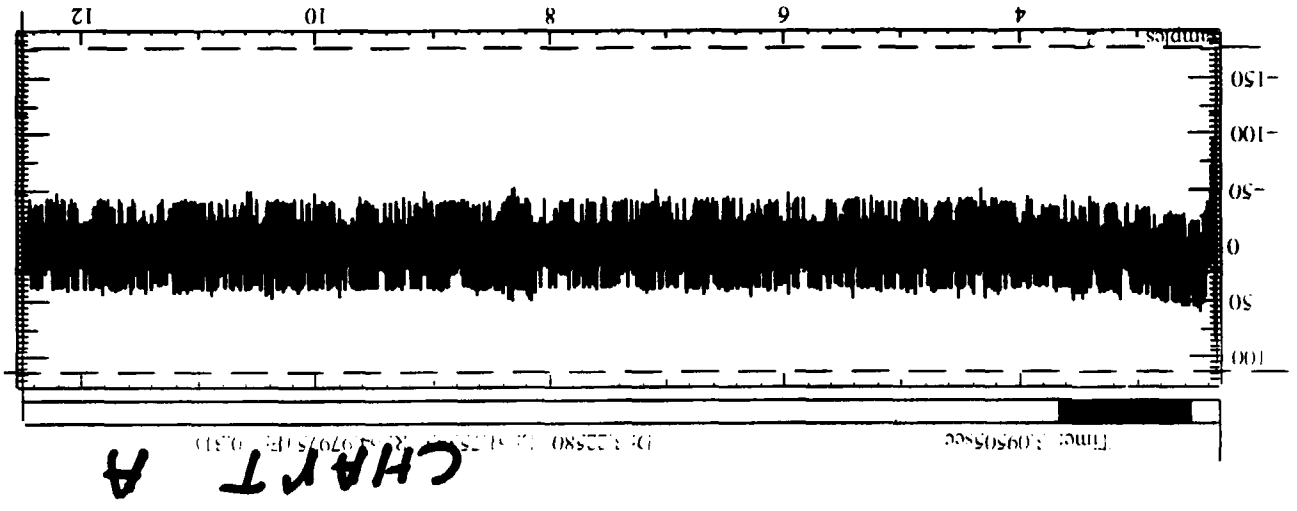
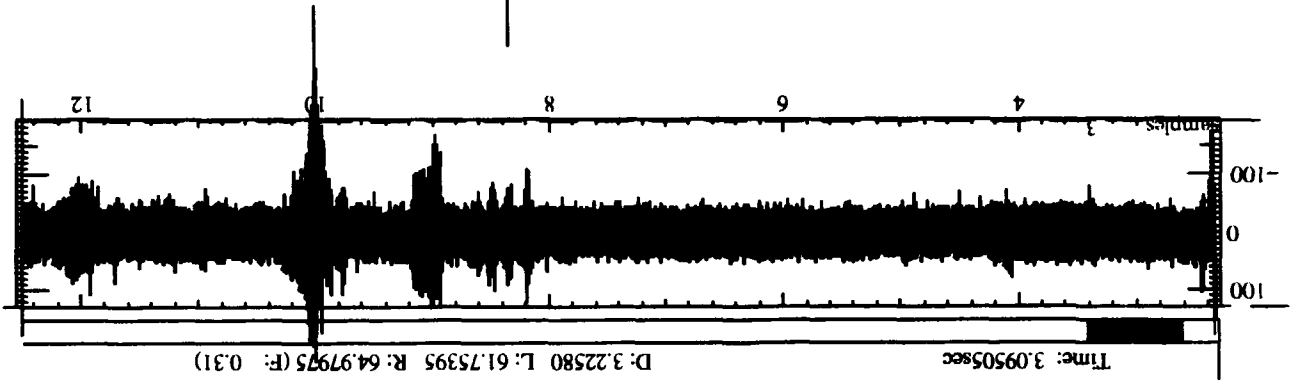
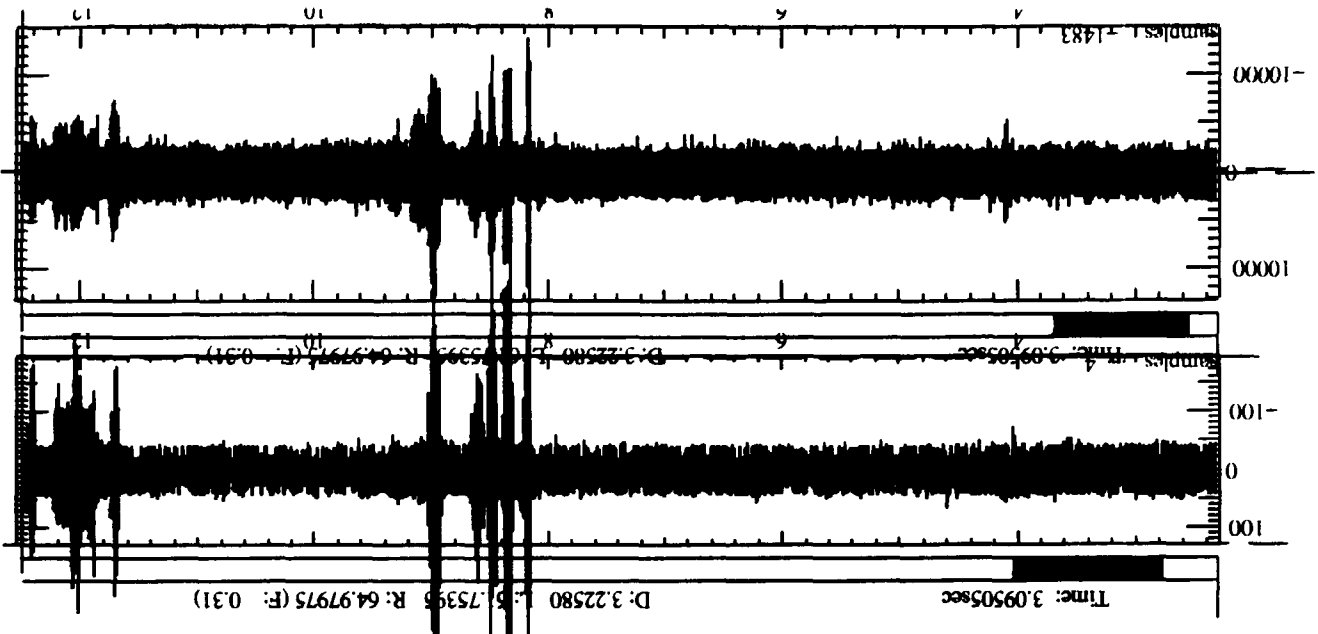
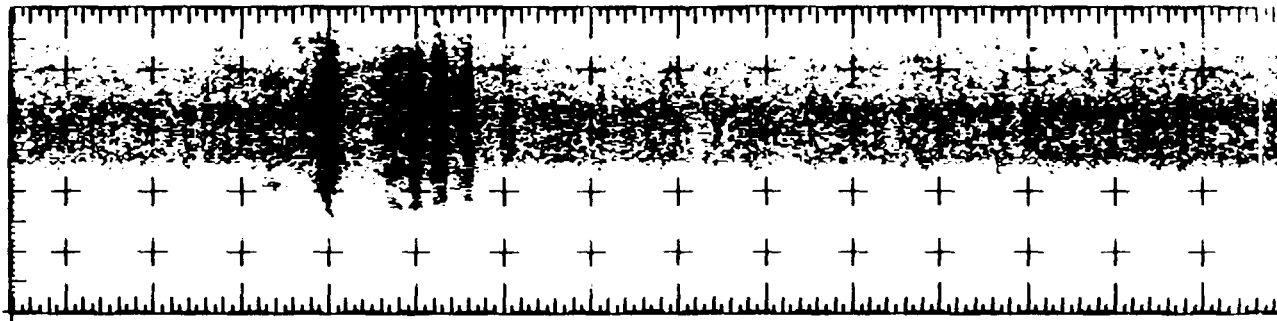
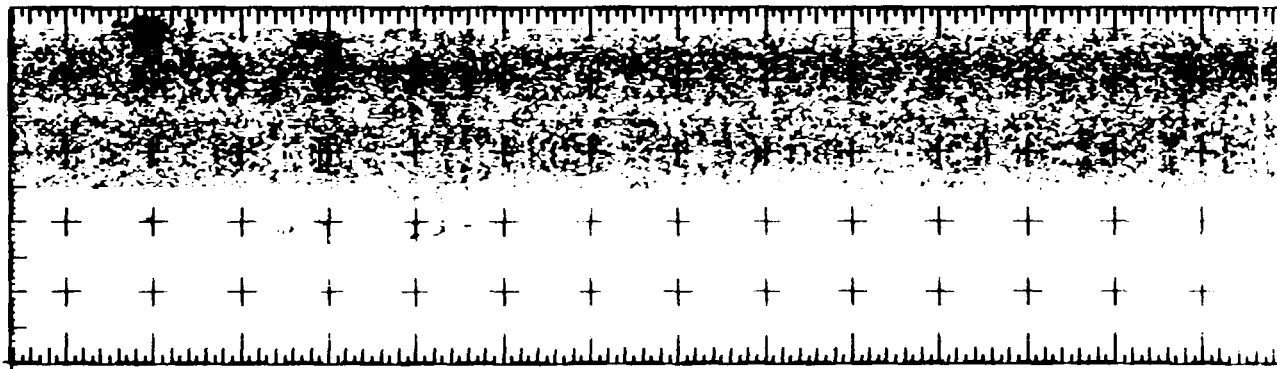
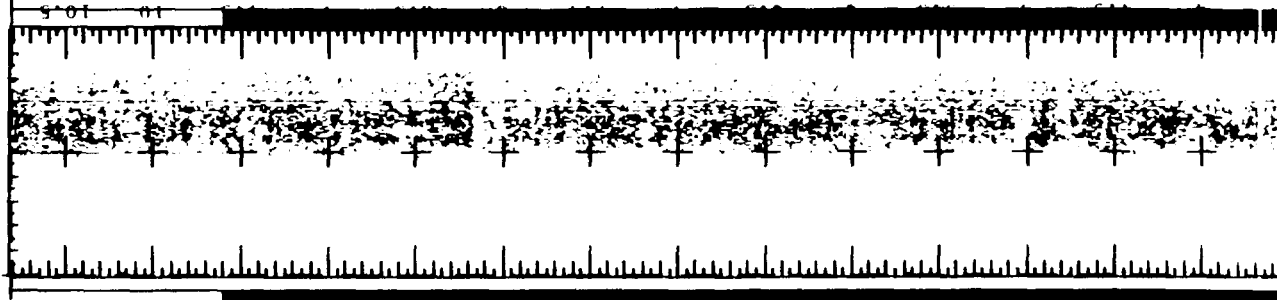
CHART A

Chart A	Test condition 001 airborne test CVR C/B Pull waveform
Chart A1	Test condition 001 airborne test CVR C/B Pull spectrogram
Chart B	Test condition 001a airborne test CVR C/B Pull waveform
Chart B1	Test condition 001a airborne test CVR C/B Pull spectrogram
Chart C	Test condition 002 airborne test CVR C/B Hard Pull waveform
Chart C1	Test condition 002 airborne test CVR C/B Hard Pull spectrogram
Chart D	Test condition 003 airborne test CVR String Pull waveform
Chart D1	Test condition 003 airborne test CVR String Pull spectrogram

cockpit sounds, the circuit breaker tests were conducted during the in-flight test. Test conditions 1, 1a, 2, and 3 were accomplished to document the sounds that were recorded on the CVR during a "soft" "hard" and string pull of the CVR circuit breaker. Charts A1, B1, C1 are spectrographs of the area microphone channel of the CVR several seconds prior to the CVR stopping. It can be seen from the charts that no identifiable sound signatures were recorded on the CVR. The addition of the background cockpit noise that is present during normal cruise totally obscured any sounds associated with the manual pulling of the cockpit circuit breaker.

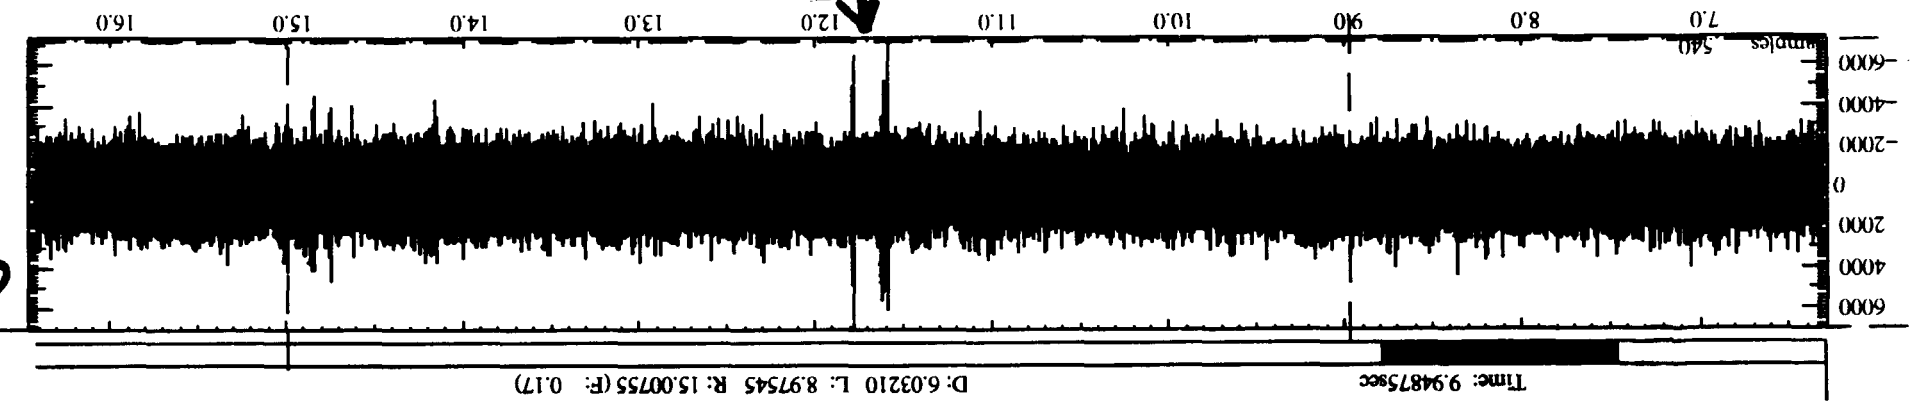
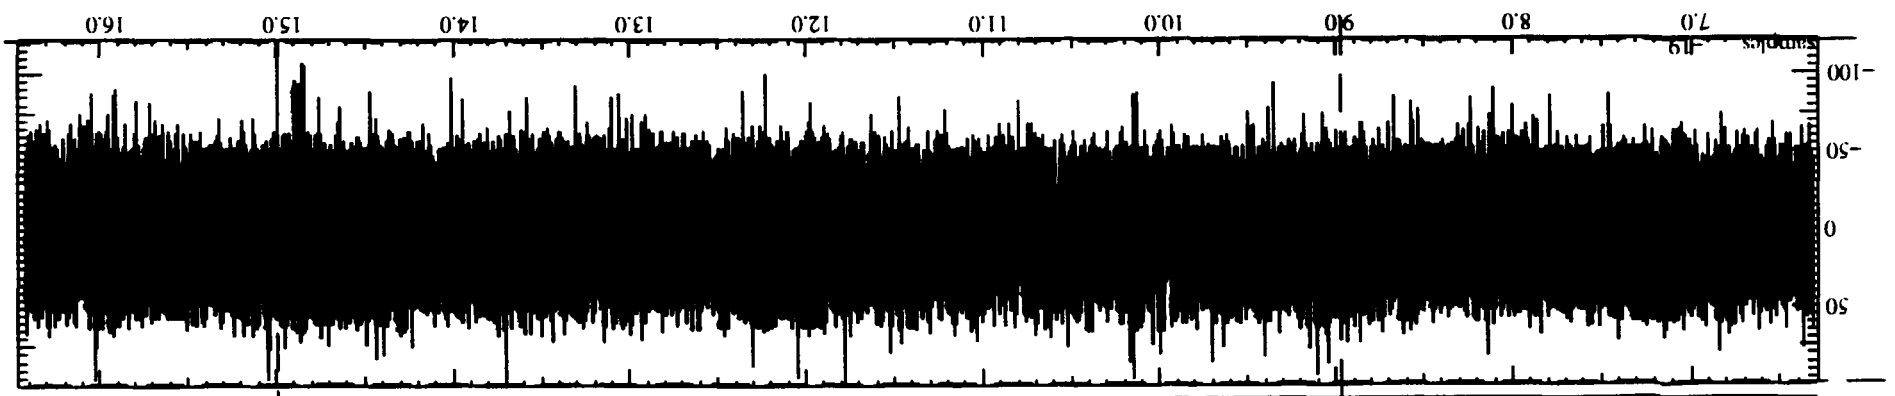
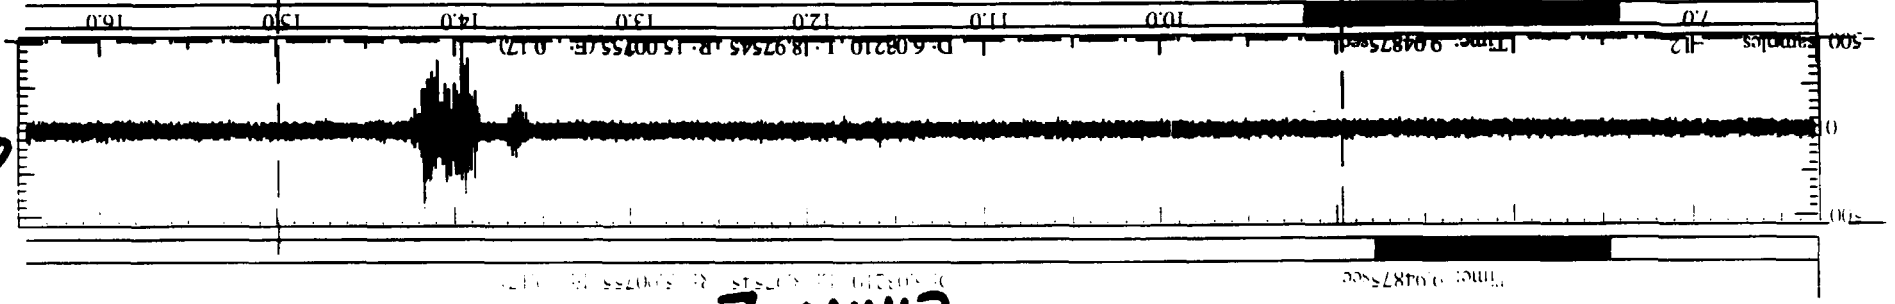
CHART E

Chart E	Test condition 007 airborne test Captains right seatbelt waveform
Chart E1	Test condition 007 airborne test Captains right seatbelt spectrogram
Chart F	Test condition 008 airborne test Captains left seatbelt waveform
Chart F1	Test condition 008 airborne test Captains left seatbelt spectrogram

It can be seen from the test flight charts (Charts E, E1) that the clunk sound associated with the right Captain's seatbelt was of sufficient intensity to be observed in all 3 of the CVR channels. The sounds associated with left hand portion of the Captain's seatbelt was only loud enough to be picked up on the area microphone and the 1<sup>st</sup> Officer's hot mike. (Chart F, F1) In this test there were no sound signatures observed on the Captain's hot microphone channel of the CVR.

5. During test flight, all 3-cockpit (cockpit area mike, Captain's hot mike, 1<sup>st</sup> Officer's hot mike) microphones picked up the sounds made by the right side of Captain's seat belt buckle hitting the floor.

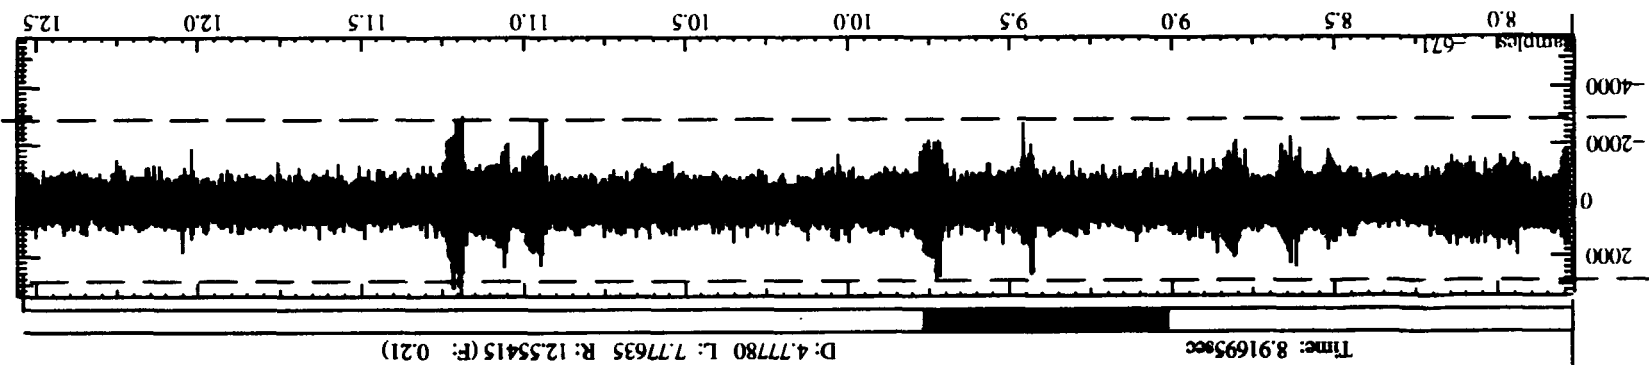
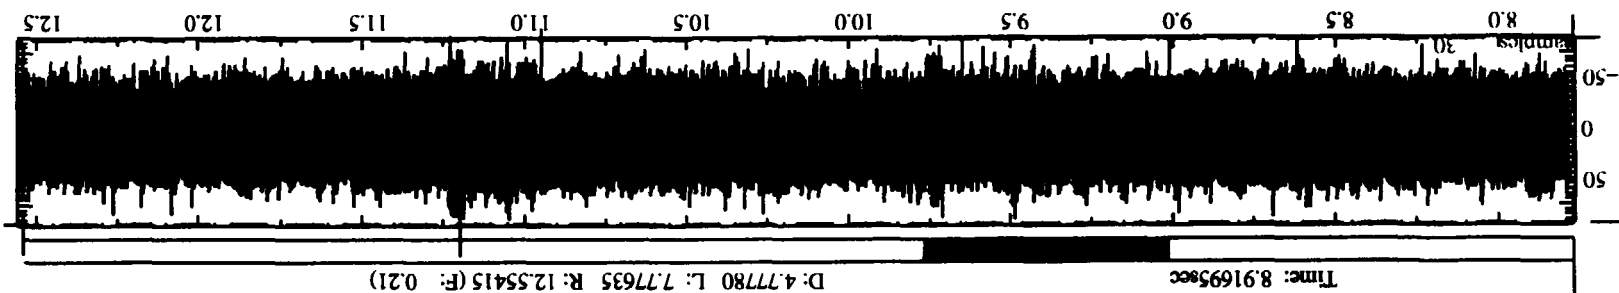
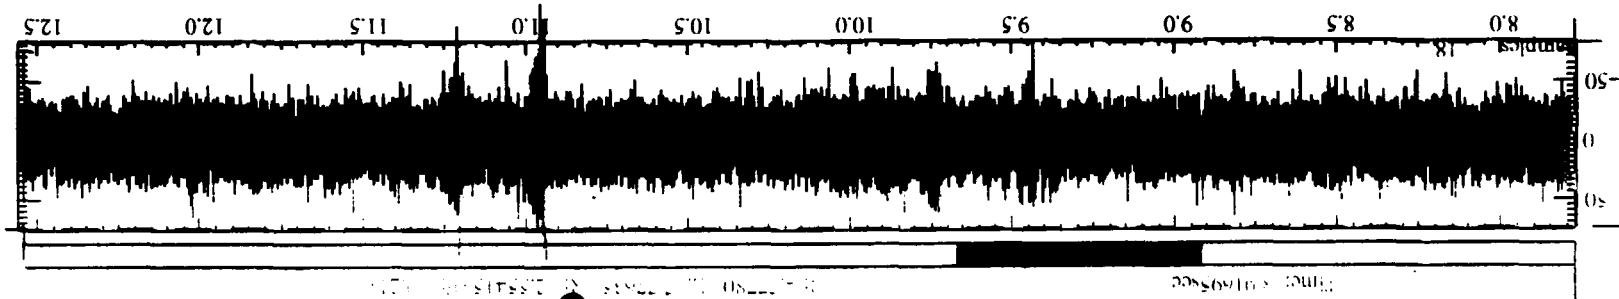
CHART 6

In the accident recording the sounds of the seatbelt clunk were picked up on the area mike (channel 4) of the CVR. This is shown in Charts G, G1 and H, H1. The sounds were also picked up by the captain's (channel-2) channel and the co-pilot's (channel-3) of the CVR recording. CVR channel-1 contained no cockpit audio information. This channel contained only air traffic control radio information.

Chart G	Accident recording 4-channel waveform
Chart G1	Accident recording 4-channel spectrogram
Chart H	Accident recording 4-channel waveform cont.
Chart H1	Accident recording 4-channel spectrogram cont.

3. If the circuit breaker can be pulled without making any noise, there are no other unique electronic sound signatures recorded on the CVR.
4. On the accident recording the sounds originating from the seat belt buckle hitting the floor is picked up by the 3 cockpit microphones (cockpit area mike, Captain's hot mike, 1<sup>st</sup> Officer's hot mike)

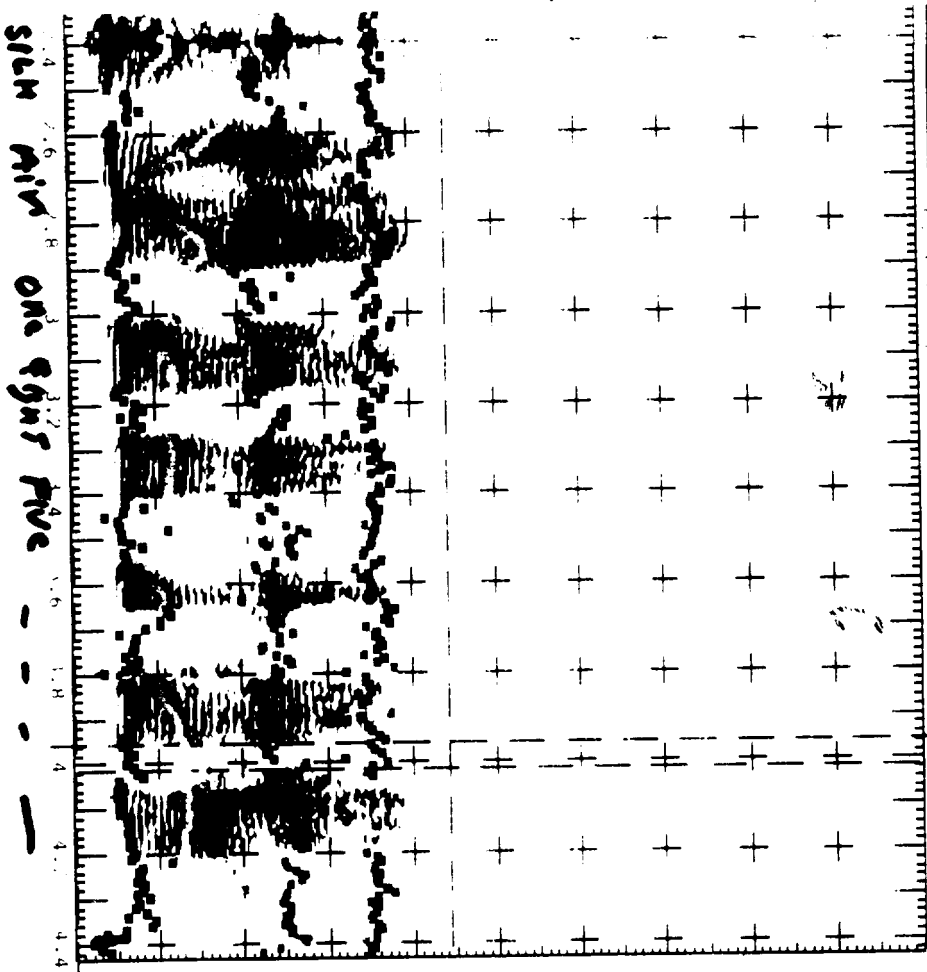
Chart I	1st Officers radio transmission spectrogram with formants
Chart J	Expanded scale 1st Officers radio transmission spectrogram

CVR  
Radio

Red - 1st FORMANT  
Yellow 2nd FORMANT  
Green 3rd FORMANT  
Blue 4th FORMANT

During the accident flight, the 1<sup>st</sup> officer was making all of the air to ground radio transmissions. During most of these transmissions he would say the flight's call sign of "SilkAir one eight five". This portion of the radio transmission was used to compare the last air traffic control radio transmission with previous transmissions from the flight. Charts J and I document what the "voice print" characteristics of the CVR radio transmission look like. These plots depict the various frequency patterns of the 1<sup>st</sup> officer's voice. To further define the voice characteristics of the 1<sup>st</sup> officer, computer generated vocal formant information is overlaid on top of the voiceprint (Chart I). The vocal formant information is a computer generated vocal cavity modeling software that models the human mouth, tongue, lips and voice box. This formant representation is unique to an individual and represents how they position their mouth, tongue and lips when they speak.

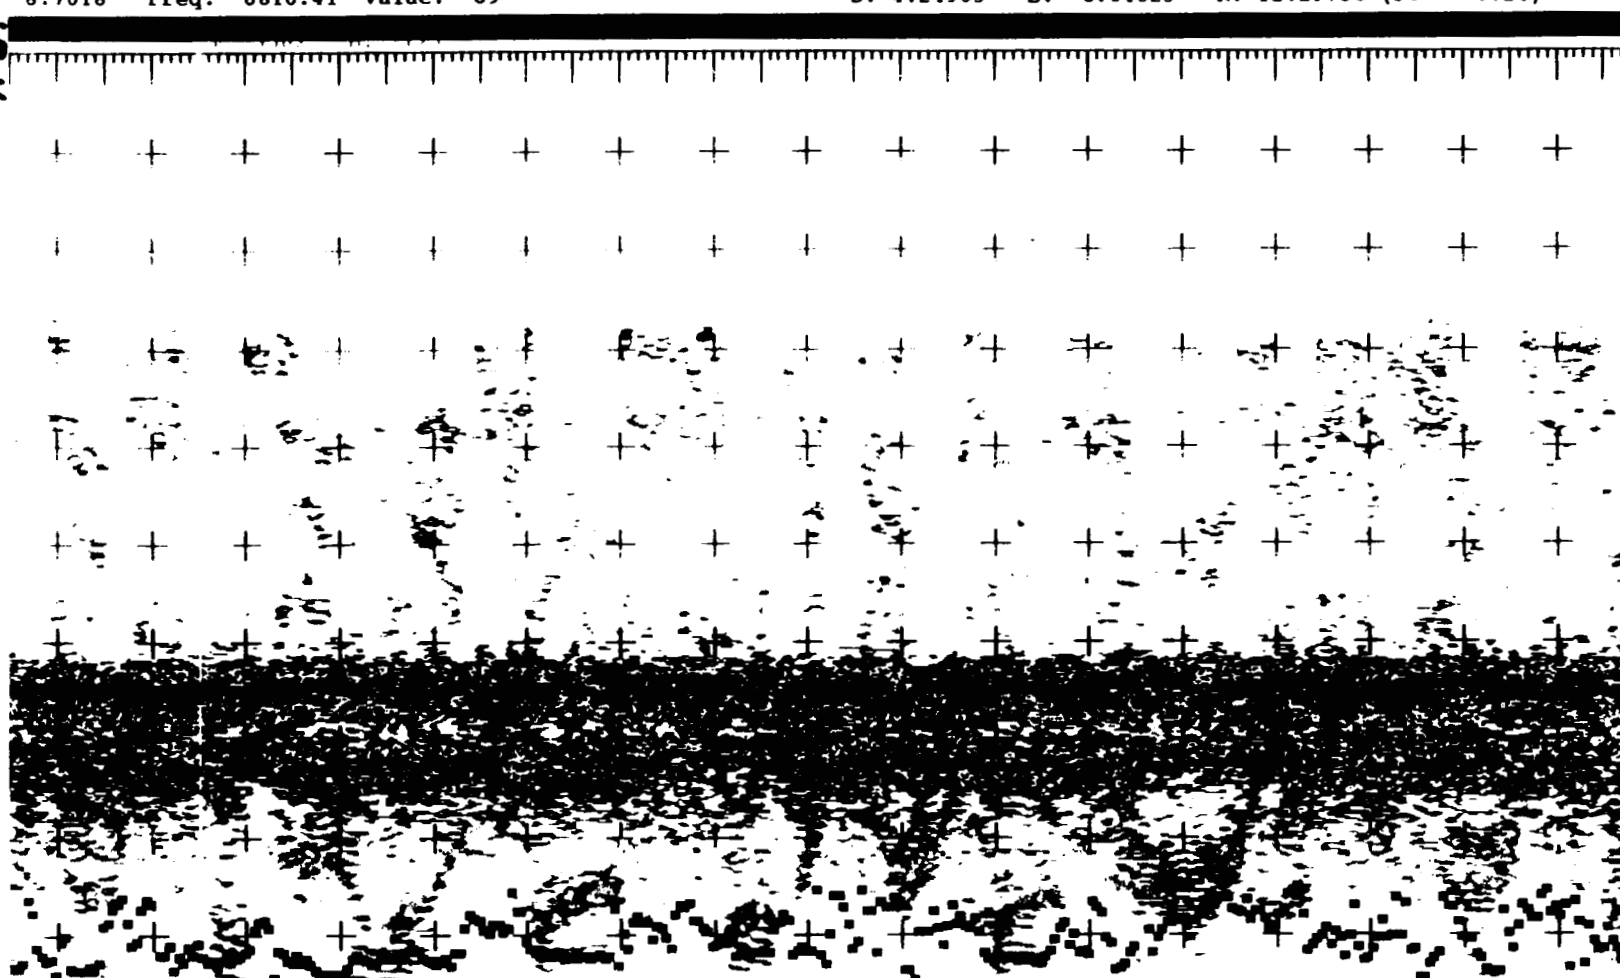
CHARI N

Chart K	Suspected 1st Officers radio transmission spectrogram with formants
Chart L	Expanded scale suspected 1st Officers radio transmission spectrogram

ATC  
RADIO

Red - 1st FORMANT  
Yellow - 2nd FORMANT  
Green 3rd FORMANT  
Blue 4th FORMANT.

Charts K and L represent the voice information from the last radio transmission recorded from the accident aircraft. Again Chart K is the voice print information with the computer overlay formants on it. The same aircraft call sign "SilkAir one eight five" was spoken in the beginning of this transmission. It can be seen from the comparison of the

two charts that the formant information is almost identical between these two segments. The most notable comparison is when the 1<sup>st</sup> officer says the call sign "SilkAir"
